**CH-21A HELICOPTER AIRFRAME DEFORMATION  
UNDER A DYNAMIC CRASH CONDITION**

**Pertaining to the Dynamic Crash Test of a U. S. Army CH-21A Helicopter**

**January 1964**

TRECOM Technical Report 63-77

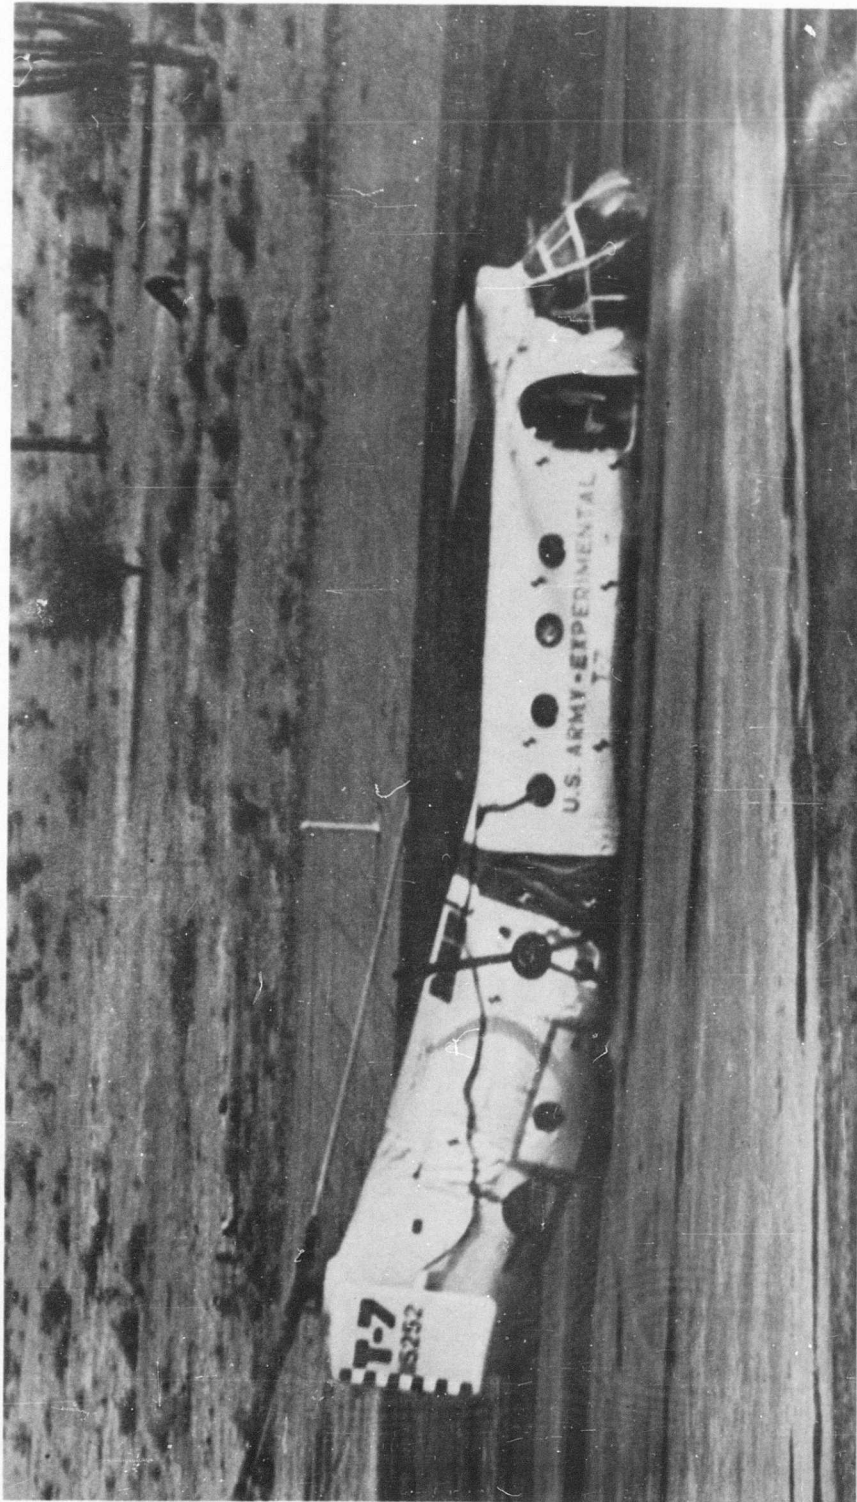
Figure 5. Test Vehicle 0.240 Second After Initial Impact.

Notice that the landing gear have failed, and that the lower fuselage is crushing due to impact. Also, notice the skin wrinkles in the dark band just forward of the main landing gear and in the tail section just above the engine compartment access door as well as the skin wrinkles below the forward rotor between the door and the cockpit. (U.S. Army Photograph)

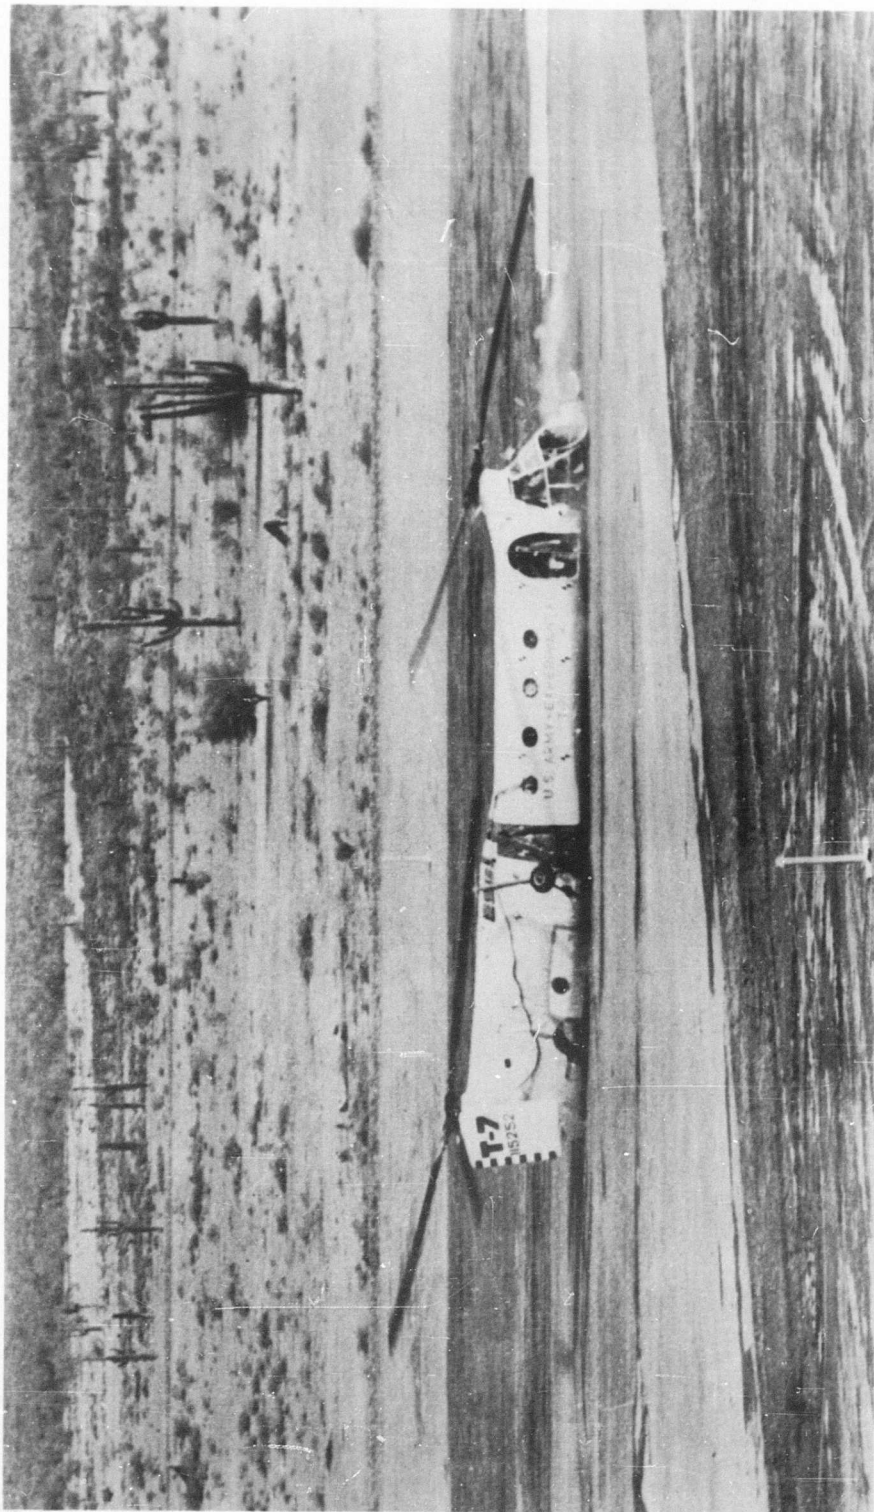
Figure 6. Test Vehicle 0.331 Second After Initial Impact.

Notice that the tail of the fuselage has bent downward until the entire bottom surface of the fuselage is in contact with the ground. It will also be noted that the fuselage is beginning to tear in the dark band just ahead of the main landing gear near the top of the fuselage. (U. S. Army Photograph)

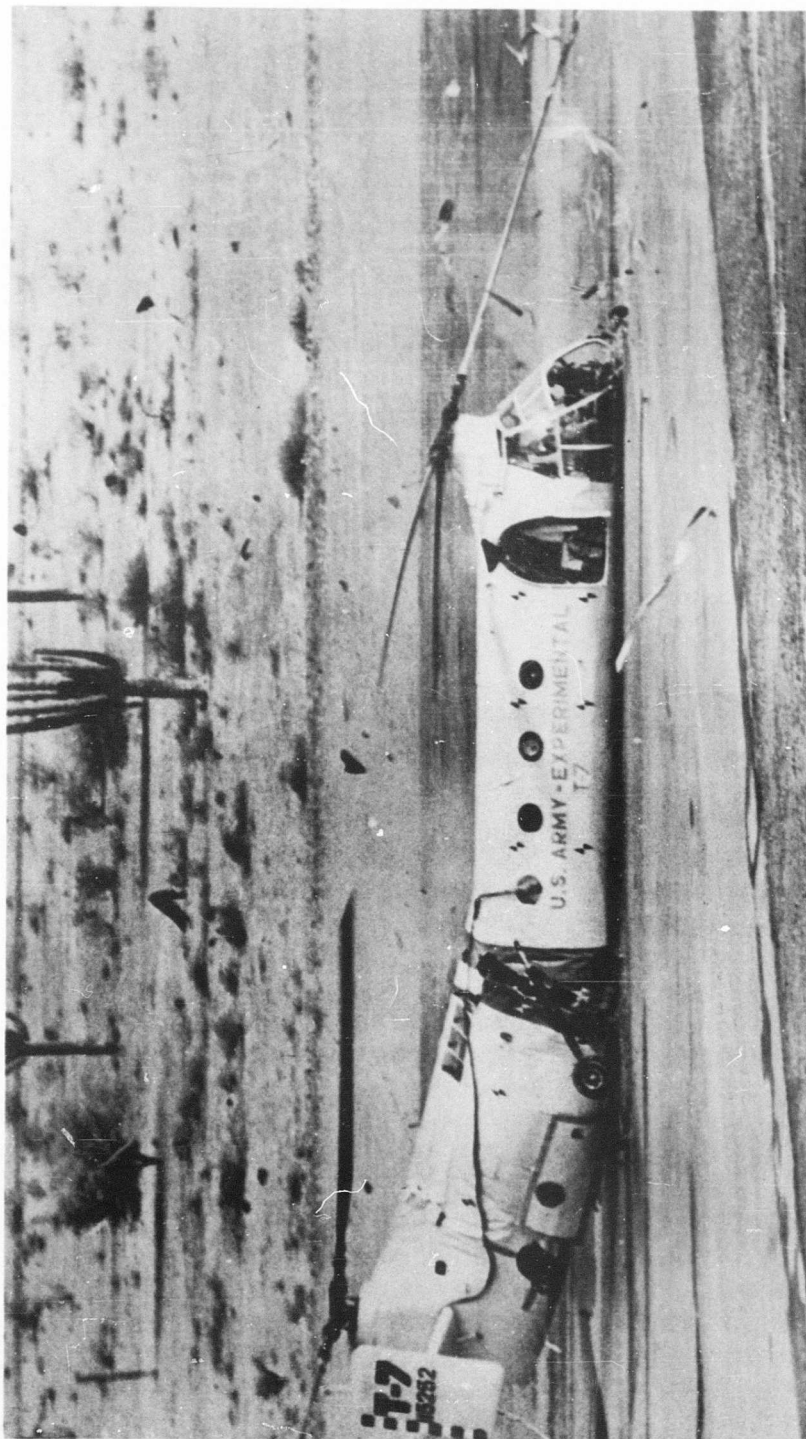
Figure 7. Test Vehicle 0.948 Second After Initial Impact.

The aircraft is bouncing and the tail is moving upward again toward its normal position. Notice that the rip in the dark band around the fuselage has opened considerably and liquid is spilling out through this opening onto the runway. Also, the forward rotor blades have now contacted the ground and are breaking up. (U. S. Army Photograph)

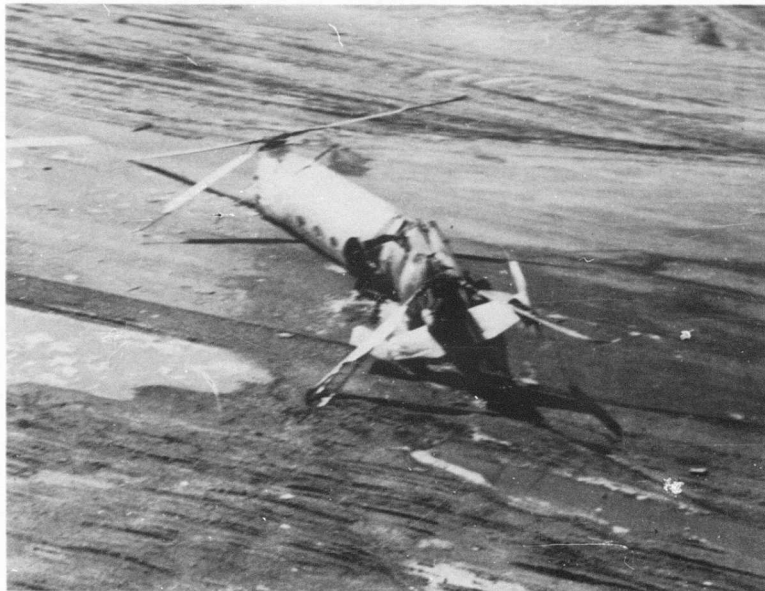
Figure 8. Attitude of Test Vehicle After the Crash. Notice how the aircraft turned to the right and the tail section bent to the left.

The entire tail section of the aircraft, aft of the break in the fuselage, came to rest bent to the left and twisted counterclockwise (viewed forward). The left vertical stabilizer contacted the ground and was consequently deformed, while the right side of the tail, which did not contact the ground, suffered little damage. When the tail bent down and to the left, both the engine drive shaft and the aft rotor drive shaft were pulled out of the center rotor transmission, which remained attached to the forward fuselage section. The engine remained attached to its engine mounts; the engine mounts and engine compartment structure maintained their structural integrity. Therefore, the engine was adequately protected from crash damage which might have added to the fire hazard.

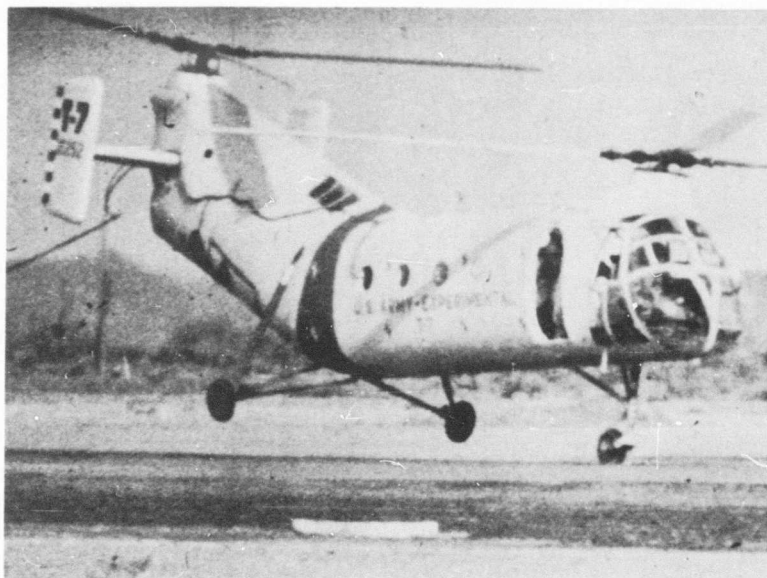
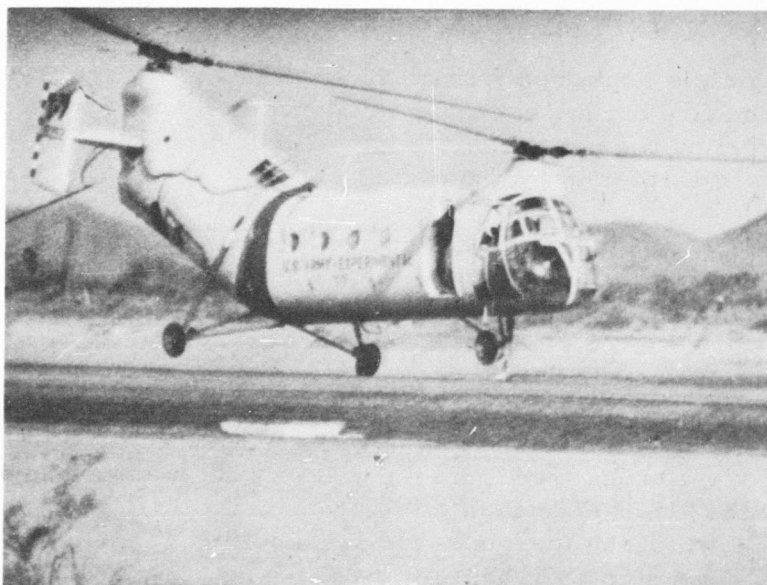
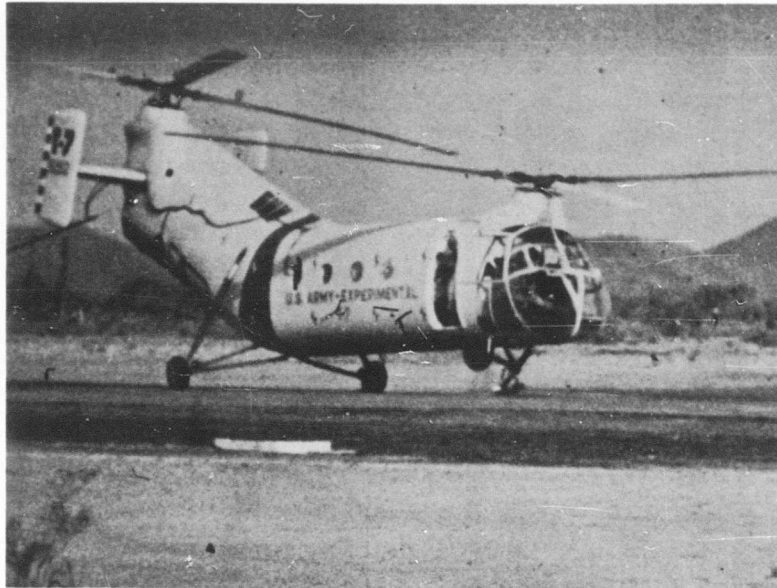
The nose wheel broke away from the oleo strut, and then the nose landing gear oleo strut broke free from the aircraft at its attachment to the fuselage. As the aircraft settled to the ground, the nose wheel bounced up into the bottom of the fuselage, and the oleo strut assembly folded aft so that both were trapped beneath the forward section of the cargo compartment (Figures 9, 10, and 11).

Figure 9. Sequence Photo of Nose Landing Gear Failure.

Figure 10. Sequence Photo of Nose Landing Gear Failure.

Figure 11. Sequence Photo of Nose Landing Gear Failure.

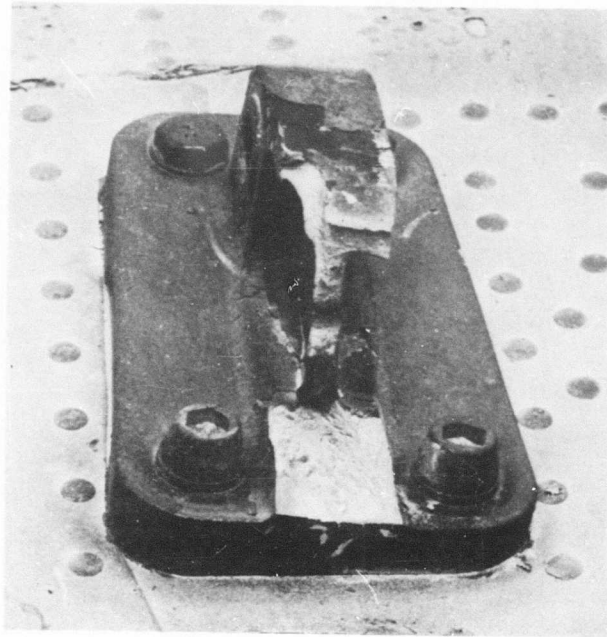
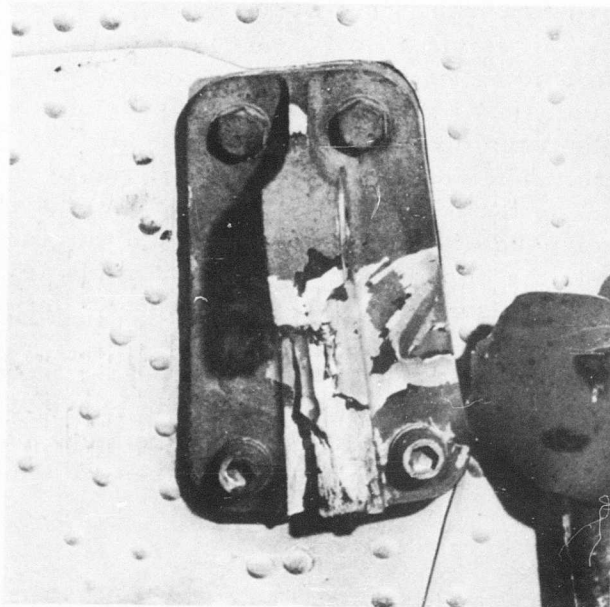
Both main landing gear support fittings, parts numbers 4251048-1 left side and 4251048-2 right side, failed (Figures 12 and 13). Study of high-speed motion picture film revealed that prior to the fitting failure, the main landing gear oleo struts were not compressed any appreciable amount; they acted as solid compression members. Impact forces were transmitted directly to the support fittings, causing their immediate failure. The oleo struts were then free to rotate about their lower attach point as the fuselage continued downward toward impact. The upper ends glanced off the fuselage skin and moved upward and outward relative to the support fittings without doing any major damage to the fuselage structure.

Figure 12. Main Landing Gear Support Fitting, Right Side.

Figure 13. Main Landing Gear Support Fitting, Left Side.

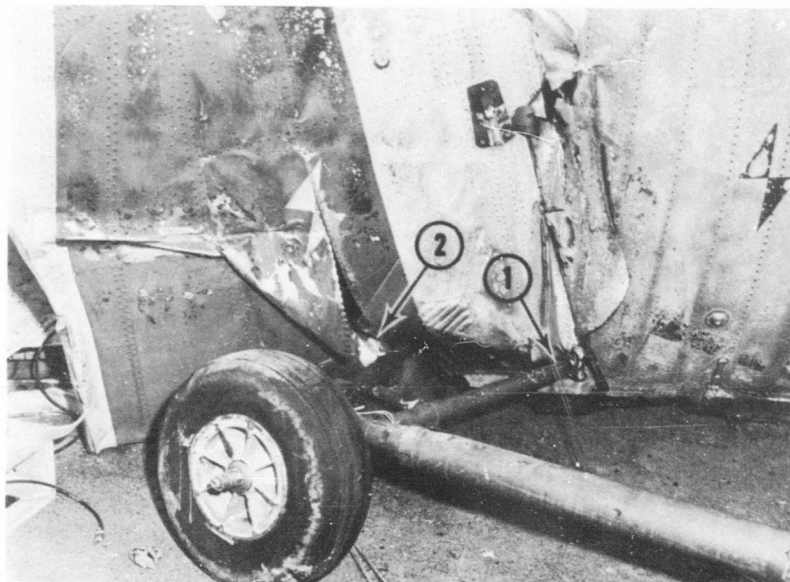
Figure 14. Left Main Landing Gear.

As the aircraft continued to settle and contacted the runway, the main landing gear V-brace assemblies punctured the lower fuselage, doing serious damage to the lower fuel tank structure and ripping the inverter from its mounts in the plenum chamber (Figures 14 and 15).

The rear V-brace (arrow 1) ripped through the fuselage and tore the inverter from its mounting in the plenum chamber. The forward V-brace (arrow 2) smashed upward into the main fuel cell.

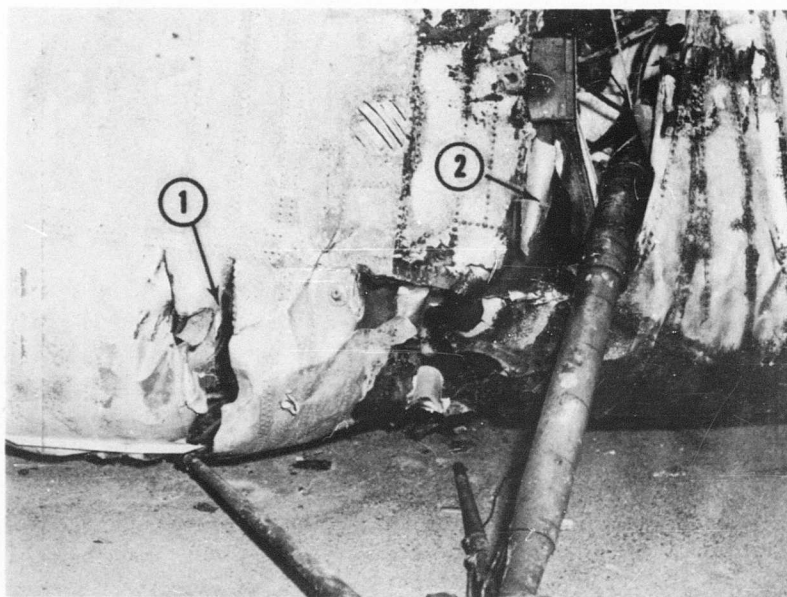
Figure 15. Right Main Landing Gear.

Notice the damage to the lower fuselage structure done by the V-brace assembly (arrow 1). Also notice the jagged hole in the main fuel cell just aft of the landing gear oleo strut (arrow 2).

The fuel tank structure was extensively damaged. The top of the tank was the only part which remained intact. Figure 15 shows the beginning of a tear at the upper right side of the front of the tank. This tear extended all the way around under the fuel tank at the forward edge, to the top of the left side. The left side of the tank and the front of the tank were buckled due to the crushing of the bottom of the aircraft by impact. The bottom of the tank was torn and punctured to such an extent that it was virtually destroyed.

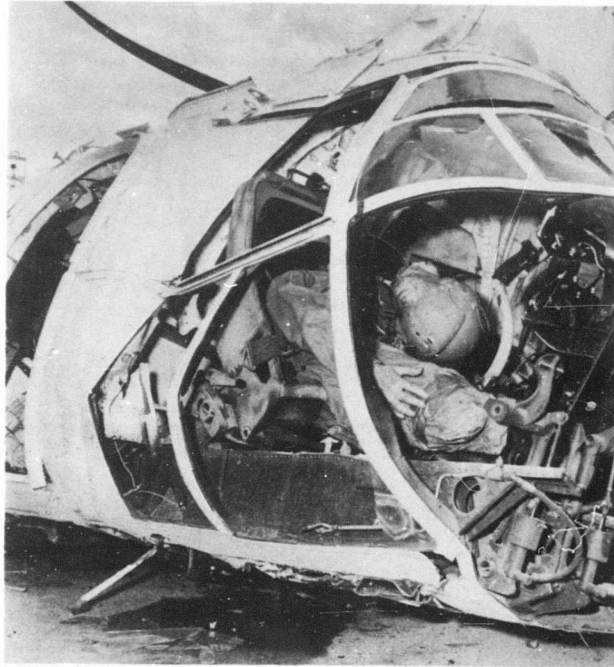
Figure 16. Right Side of Cockpit Following Crash.

The primary structure in the cockpit area remained essentially intact. The floor sustained only minor damage, which was apparently caused by the failure of the pilot's seat and its subsequent impact with the floor. The main floor beams did not fracture when the fuselage substructure crushed, but permanent deformation did occur.

Note the deformation of the window frame structure and the pilot's seat extending partly out one window. Also notice the window frame structure resting on the instrument console.

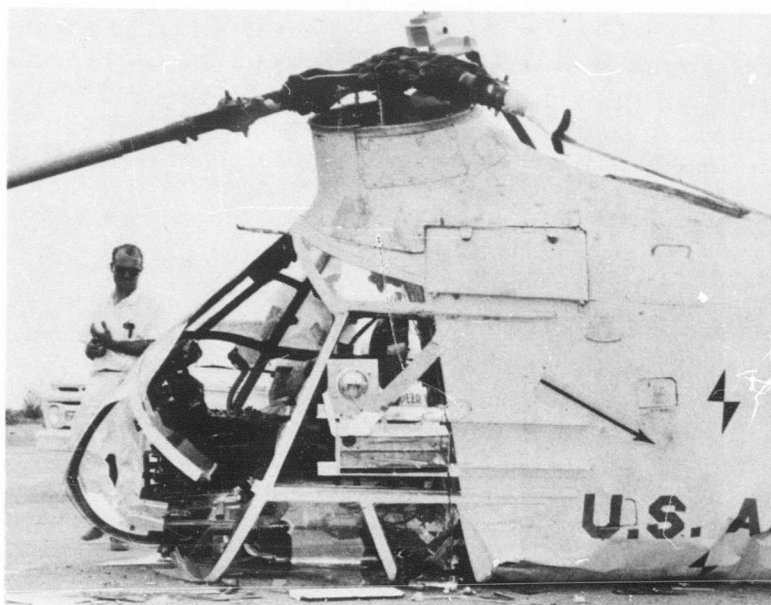
The bulkhead behind the pilot's seat, fuselage station 97.036, partially collapsed due to the high compressive load imposed upon it by the forward rotor transmission. The partial failure of this bulkhead allowed the transmission and rotor head to move downward and forward, causing collapse of the cockpit window frame structure, which then struck the instrument console (Figure 16). All the cockpit windows were broken. The partial failure of the station 97.036 bulkhead also resulted in buckling of fuselage skin aft of this station (Figure 17).

Figure 17. Left Side of Cockpit Following Crash. Notice the deformation of window frame structure and the skin wrinkles aft of the cockpit (arrow).

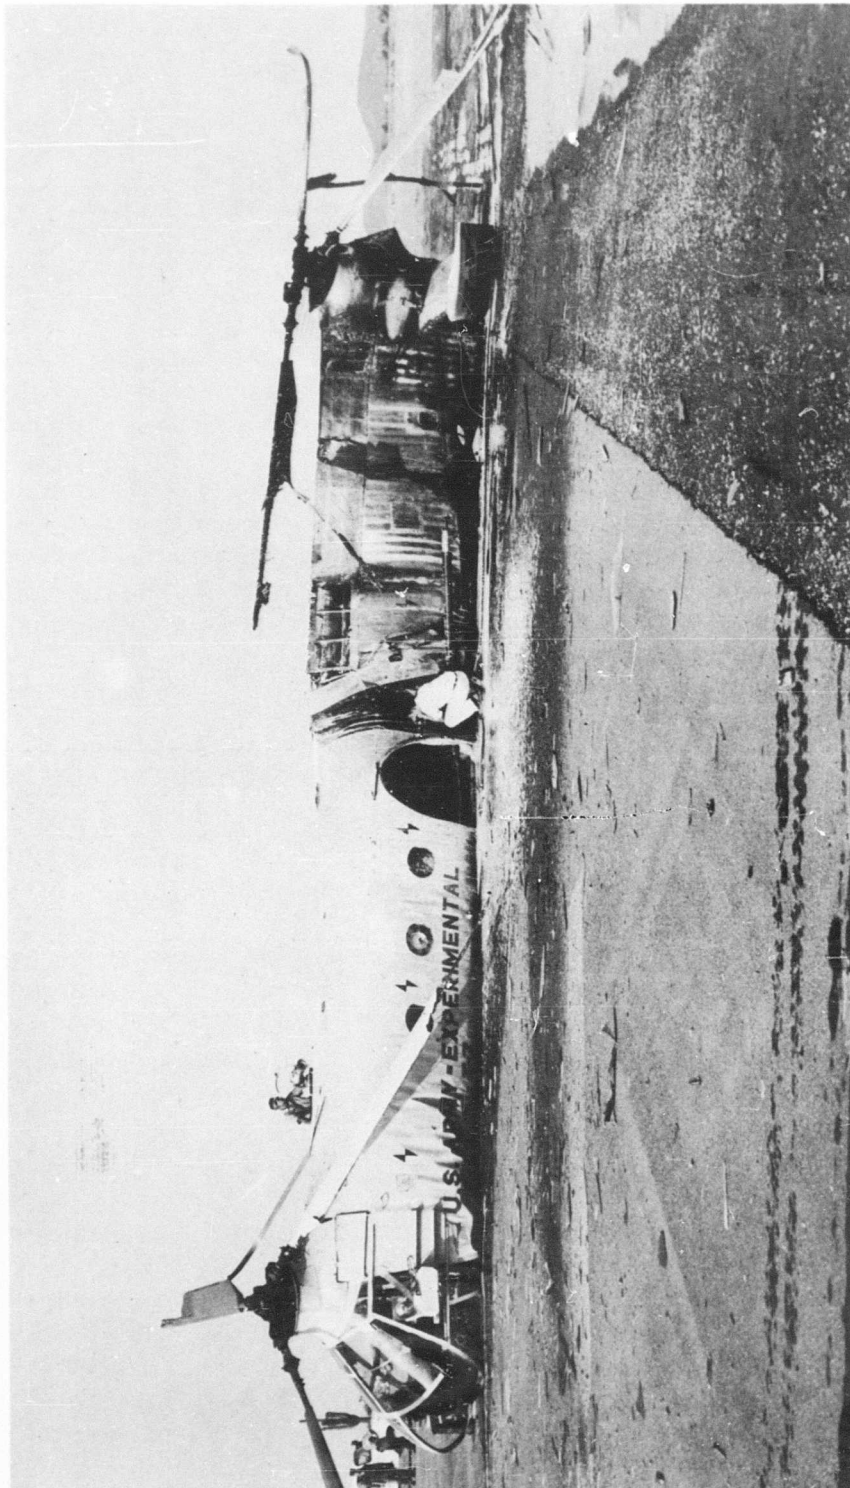
Figure 18. Overall View of Left Side of Aircraft Wreckage.

The entire cargo compartment lower body, including fuselage skin, floor support structure, and lower sections of body frames, was crushed by impact. Because the aircraft impacted with a slight left roll (Figure 4), the lower fuselage sustained more damage on the left side than on the right side.

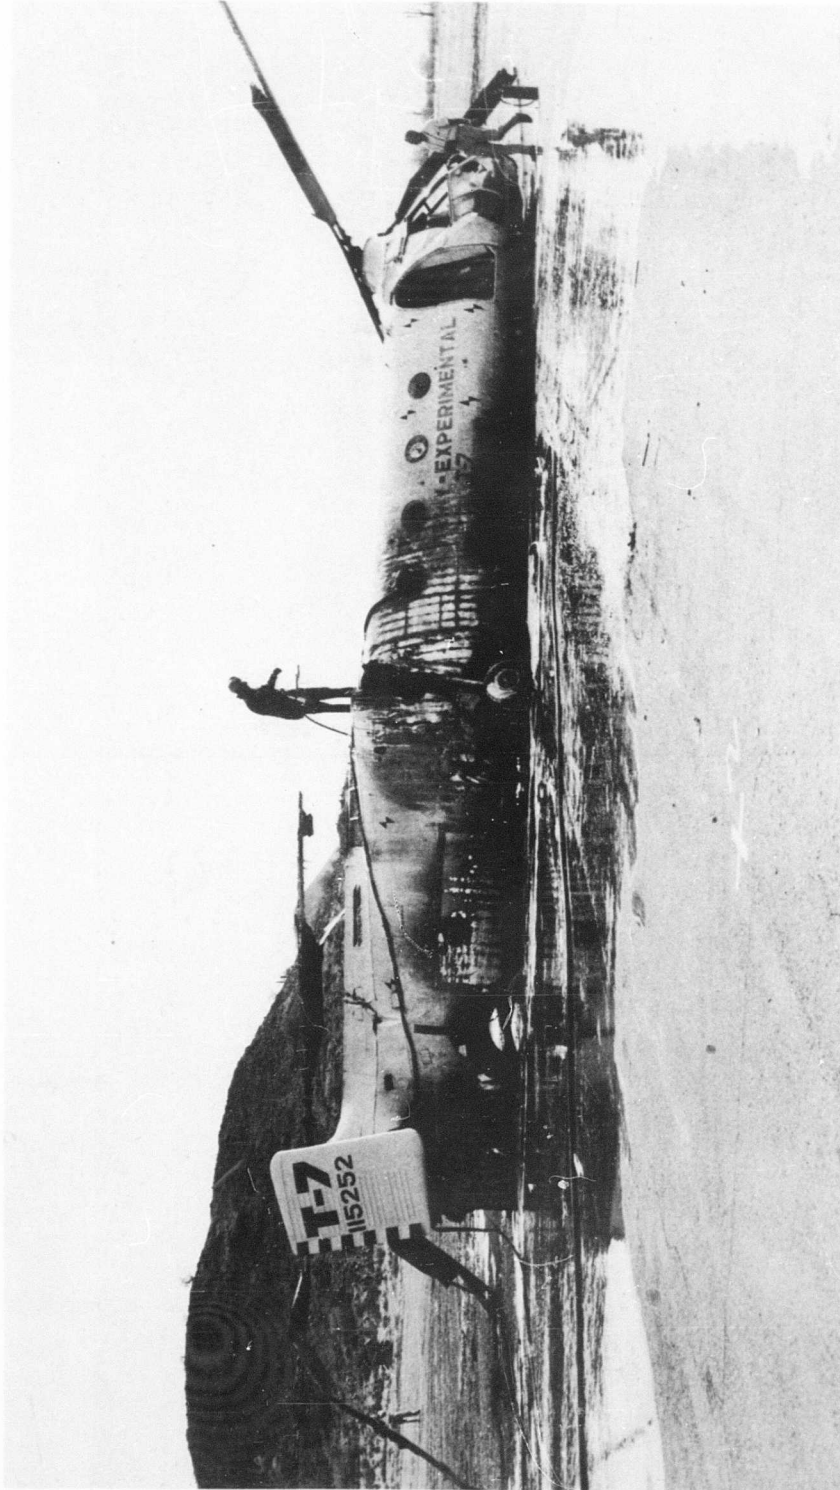
Figure 19. Overall View of Right Side of Aircraft Wreckage.

Notice that the lower fuselage structure is not damaged as badly on this side as it is on the left side, due to the slight roll which was present at impact.

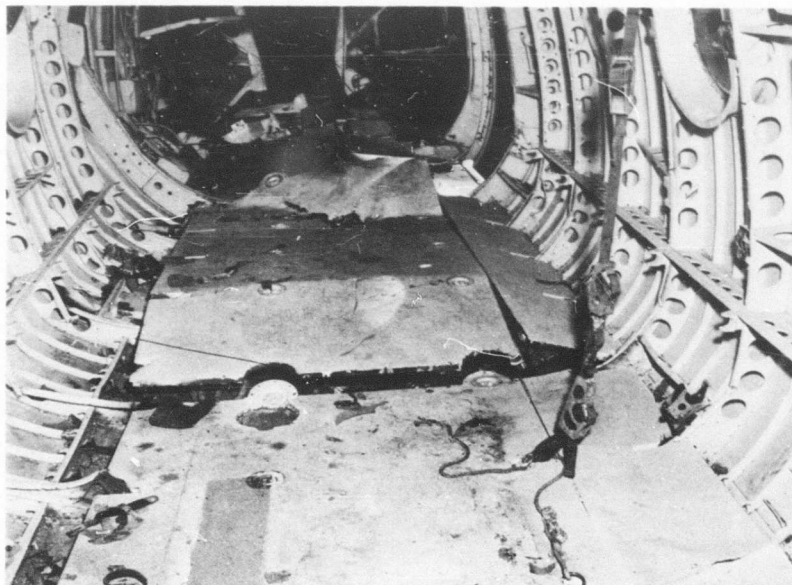
Figure 20. Overall View of Passenger Compartment Floor. This view is toward front of aircraft, after removal of experimental equipment.

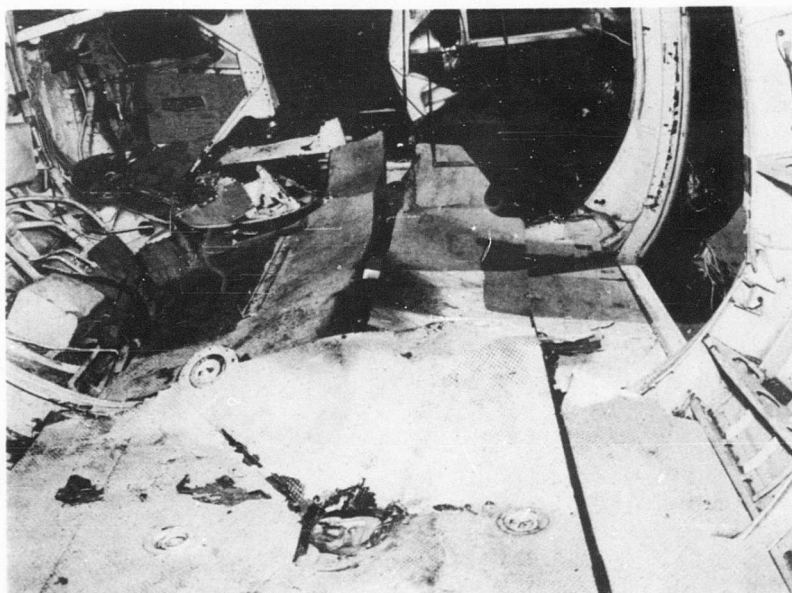
Figure 21. Severe Buckling of Passenger Compartment Floor, Fuselage Station 100 to Fuselage Station 160. This deformation was caused by the collapsed nose landing gear which was trapped beneath the fuselage.

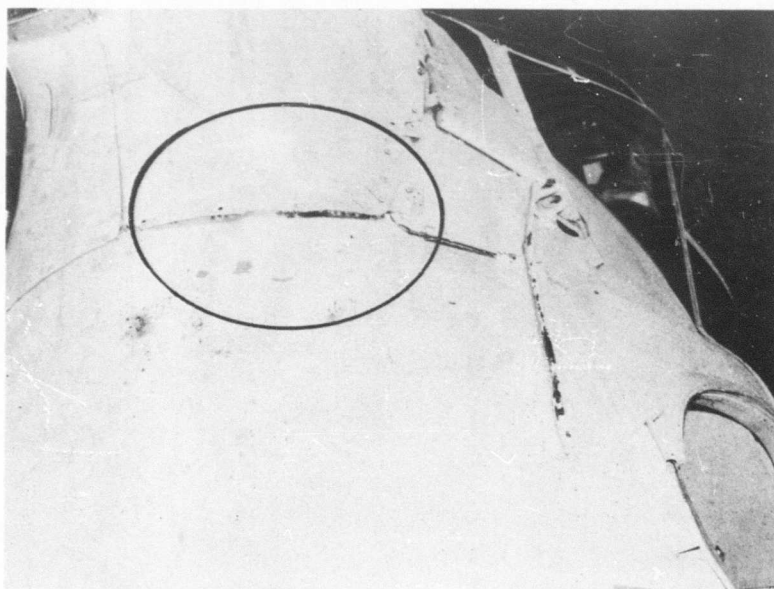
The forward displacement of the forward rotor transmission and rotor head assembly caused the failure of a row of fasteners at the junction of the fuselage station 119.50 bulkhead and the upper fuselage skin at the aft edge of the right side cowling assembly, part number 2258020-7. The tearout of this row of fasteners progressed outboard into a tear of the fuselage skin panel immediately outboard of the cowling assembly. The upper fuselage skin aft of the fastener failure was buckled due to the tensile load which was applied by the forward displacement of the rotor head.

Figure 22. Upper Fuselage Aft of Forward Rotor Head.  
This photograph shows the separation of the cowling and the skin panel on the upper fuselage skin aft of the forward rotor head, fuselage station 119.50.

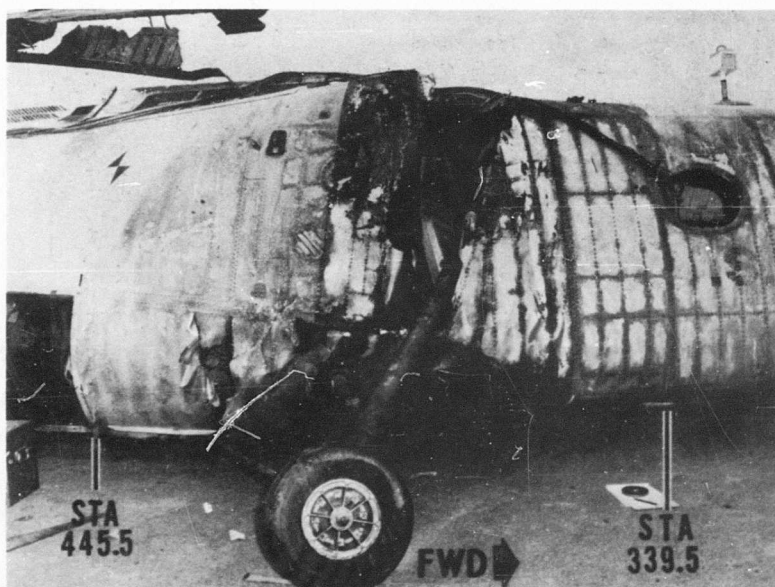
The break in the fuselage extended from beneath the fuel tank on the bottom of the aircraft, up the right side, and over the top of the aircraft. The fuselage structure beneath the fuel tank and plenum chamber was badly mangled by a combination of impact, sliding, and puncturing by the main landing gear V-brace assemblies. The V-braces punctured the fuselage on both sides of the aircraft.

Figure 23. Fuselage Failure, Right Side.

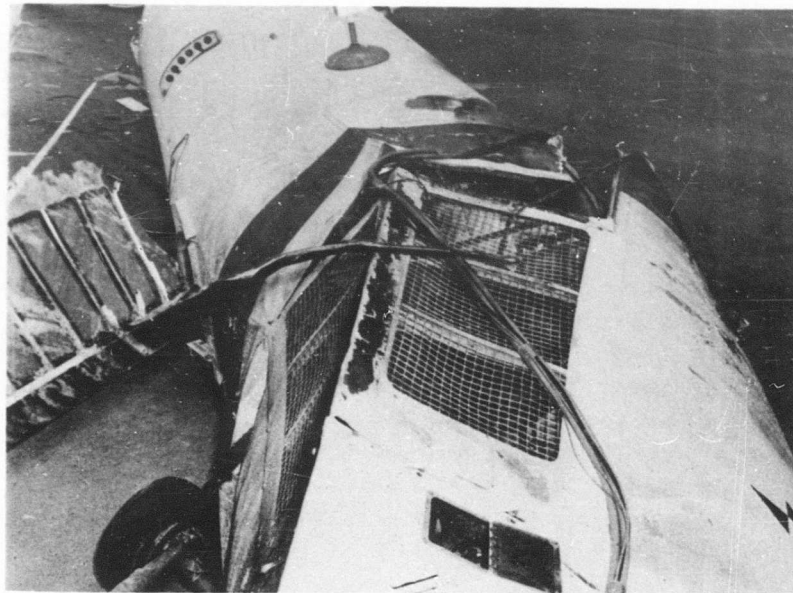
Figure 24. Fuselage Failure, Top View.  
View looking forward showing the continuation of the fuselage rupture over the top of the fuselage. Notice the angular deflection of the entire tail section.

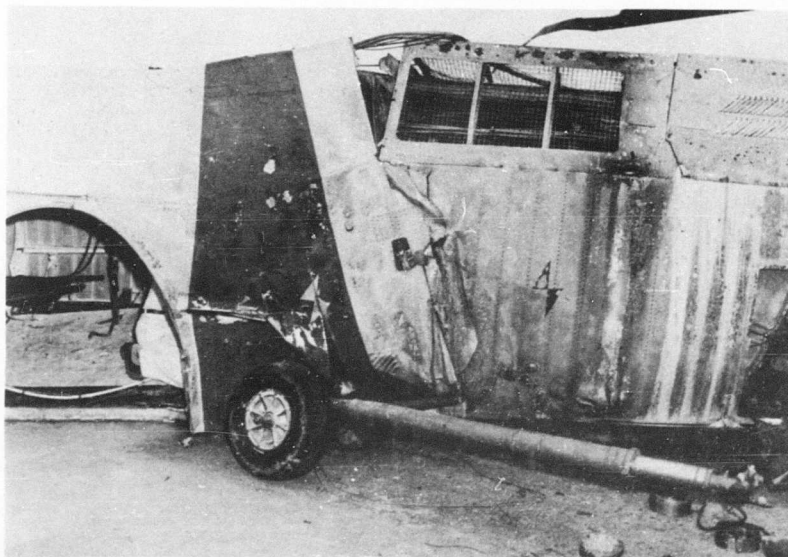
Figure 25. Fuselage Damage, Left Side, Opposite Fuselage Break.  
This photograph shows the structural failures opposite the ruptured fuselage skin.
